Glenwood Elementary School I Survey

1135 Windsor Drive I Thousand Oaks, CA 91360

Conejo Valley Unified School District

December 9th, 2016 - DRAFT v1

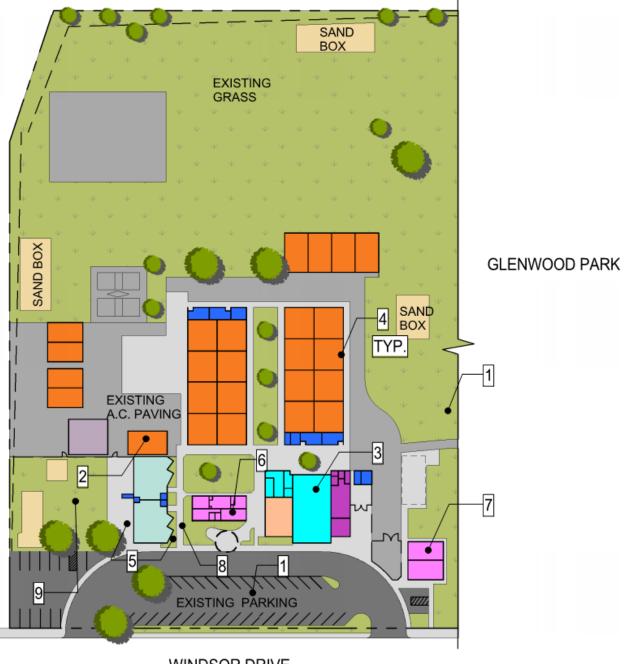
EXISTING SITE PLAN I GLENWOOD ELEMENTARY SCHOOL BUILDING USE

- 1 LACK OF LIGHTING TO ADDRESS SECURITY **CONCERNS AT NIGHT**
- LACK OF SHADING FOR PLAYGROUND AREA, TYP.
- THE MPR DOES NOT HAVE A STAGE
- LACK OF WINDOW SHADING AND OPERABLE WINDOWS, TYP.
- DRAINAGE ISSUE
- LACK OF WORK SPACE FOR TEACHERS' WORKROOM, STAFF RESTROOMS DO NOT HAVE THE PROPER CAPACITY
- 7 6 YEARS OLD PORTABLE BUILDING MOSTLY USED AS STORAGE SPACE
- NO PANIC HARDWARE FOR MAIN ENTRY **GATE**
- KINDERGARTEN PLAYGROUND IS **OVERCROWDED**

- OLDER CLASSROOMS WILL NEED ACCESSIBILITY UPGRADES ON HARDWARE THRESHOLDS AND SINKS
- EXTERIOR DRINKING FOUNTAINS WILL NEED TO BE MADE ACCESSIBLE
- ACCESSIBILITY UPGRADES NEEDED IN PARKING, GATE LOCATIONS, DOORS, AND SOME PATHWAYS
- PAINT CONDITION AND MANY EXPOSED WOOD RAFTERS ARE DETERIORATING AND IN NEED OF REFINISHES THROUGHOUT CAMPUS.
- LACK OF INDOOR FLEXIBLE SPACES AND STORAGE **SPACES**
- WINDOWS HAVE BUCKLING FRAMES, NON-MATCHING, SINGLE PANE CLASS

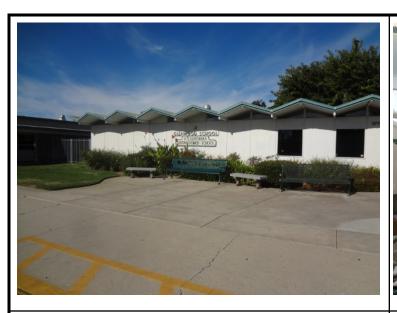
Photo -1
Building 1

Administration building and primary entrance to the school.

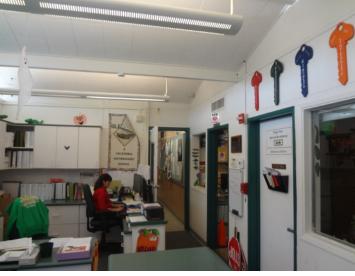
Photo -2 Building 1

Interior of administration building has good natural light. Finishes need to be updated.

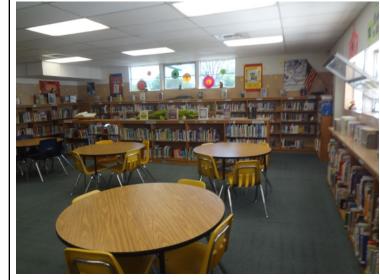
Photo -4 Building 2

Library in multi purpose building has a good layout and natural day light, finishes are old and need replacement.

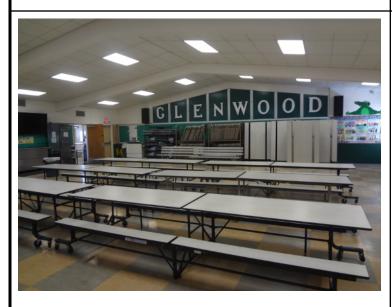
Photo -5 Building 2

Multi Purpose dining space, has fold out tables and is sufficient to the needs of the school. There is no permanent stage.

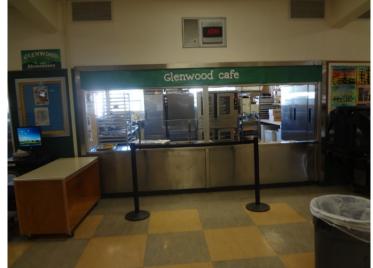
Photo -6 Building 2

Lunch line area is sufficient to the needs of the school.

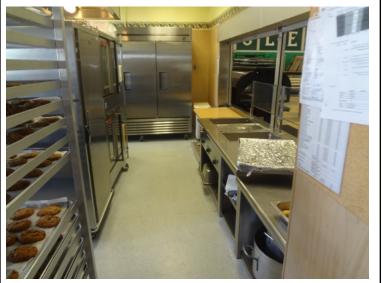
Photo -7 Building 2

Warming kitchen and food preparation is sufficient to the needs of the school.

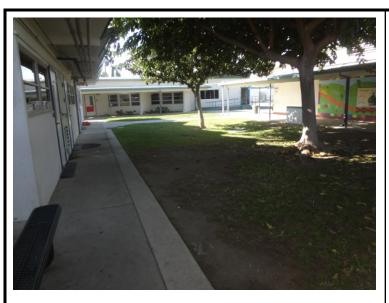
Photo -9 Building 6

Classroom buildings have courtyard between them then and are very well shaded.

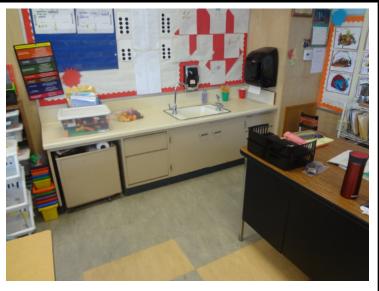
Photo -10 Building 6

Typical permanent classroom. Finishes need to be updated. Class has promethean board.

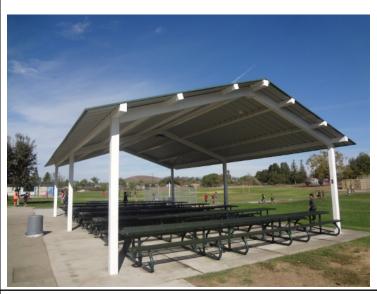
Photo -17 Building 12

Lunch shelter is relatively new and sufficient to the needs of the campus.

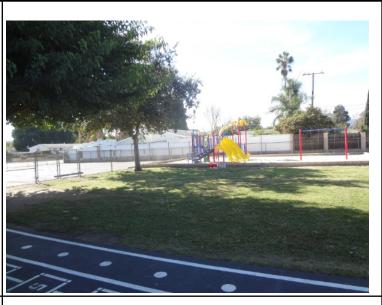
Photo -18 Building 2

Kindergarten play area and play equipment are sufficient to the needs of the campus.

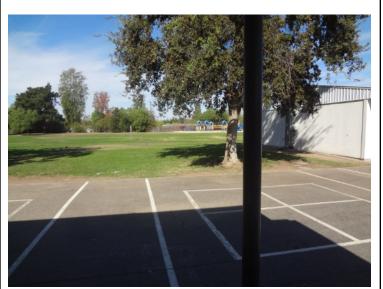
Photo -19 Building 6

View looking out on the play ground at the play equipment. The playground and play equipment are sufficient to the needs of the campus.

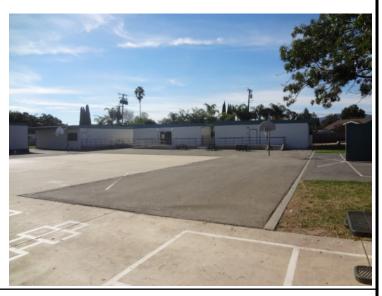
Photo -20
Basketball Courts

Blacktop area is sufficient to the needs of the campus.

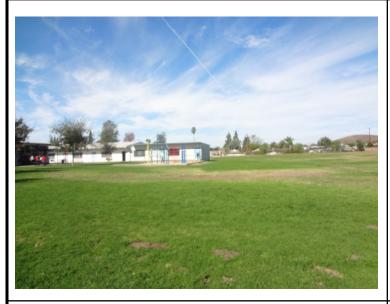
Photo -21 Playground Area

The playground and play equipment are sufficient to the needs of the campus.

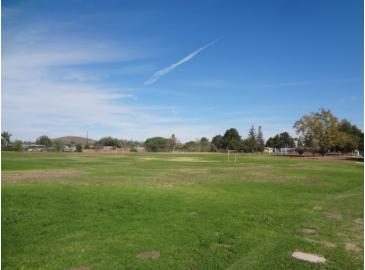
Photo -22 Playground Area

The playfield is large and meets the needs of the campus.

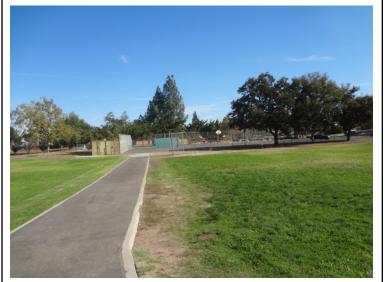
Photo -23
Playground Area

Playground boarders Glenwood Park. Lack of lighting presents a security concern at night.

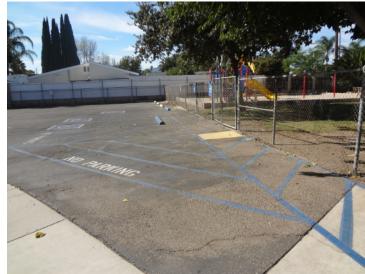
Photo -24

Accessible Parking Stalls

Parking stalls are not fully compliant with current accessibility standards.

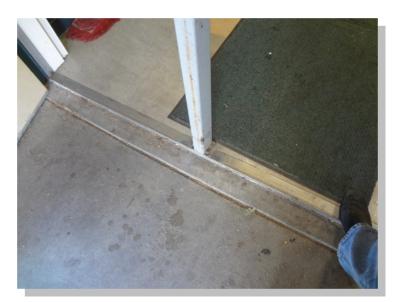
Photo -1
The door thresholds are original and have not been modernized to current accessibility standards.

As often required by Division of State Architects, a campus wide ADA upgrades will also need to be considered as a part of any large modernization effort. Non-conforming door hardware, thresholds must be replaced. Trough styled drinking fountains must be replaced with separate hi-low style counterparts while proper barrier rails or alcove should be introduced. Numerous concrete walkway with slopes exceeding the legal limits should be replaced and re-graded. In some instances, handrails will need to be added to designated ramps. At the parking area, curb cuts with truncated domes must be installed to protect the visually impaired users to the school.

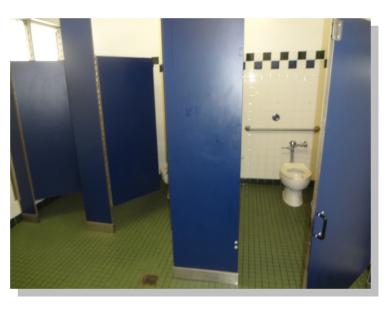
Photo -2
The restrooms have been modernized to meet current accessibility standards.

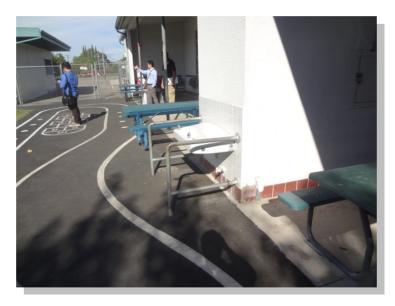
Photo -3
The drinking fountains on campus are not current with accessibility standards.

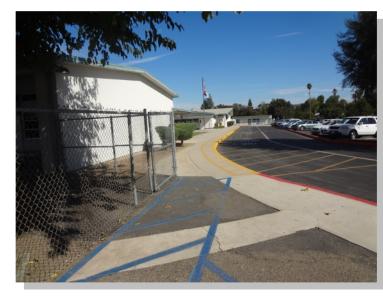
Photo -4
There are two accessible parking locations. Both do not fully comply with accessibility standard.
