Thousand Oaks High School I Site Analysis

2323 N Moorpark Rd, Thousand Oaks, CA 91360

Conejo Valley Unified School District

January 10th, 2017

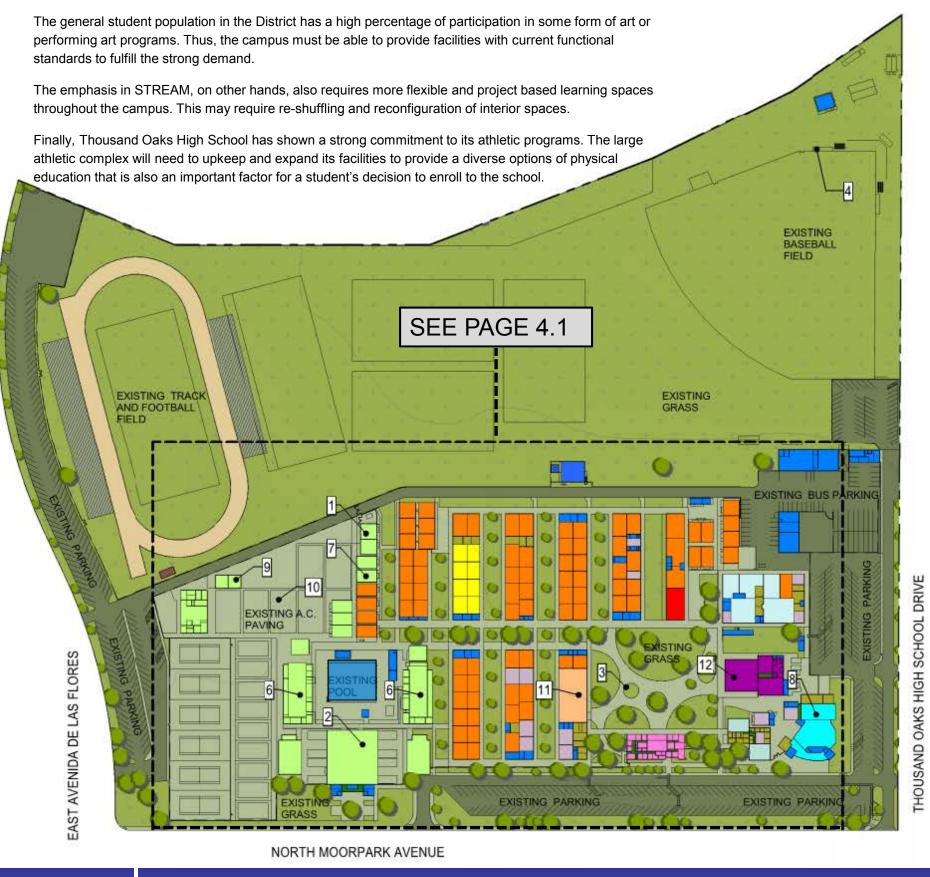
- 1 PORTABLE IN POOR CONDITION.
- 2 ACOUSTICAL ISSUES IN GYM.
- 3 CONCRETE SLAB SETTLEMENT ISSUES
- 4 PORTION OF BLEACHERS REQUIRES UPGRADE
- 5 NO HVAC IN MULTI PURPOSE / CAFETERIA
- 6 LOCKER ROOMS AND LOCKERS IN POOR CONDITION.
- 7 FOOTBALL PLAYER LOCKER ROOMS IN PORTABLE BUILDINGS WITH POOR VENTILATION.
- 8 GROUND WATER INTRUSION ISSUE BELOW THE STAGE OF PERFORMING ARTS BUILDING
- 9 WEIGHT ROOM FOR ALL SPORTS EXCEPT FOOTBALL IN TEMPORARY STRUCTURE WITH POOR VENTILATION.
- EXISTING A.C. PAVING OF BASKETBALL COURTS WITH FADED STRIPING AND EXCESSIVE CRACKS ON THE GROUND SURFACE.
- 11 LIBRARY FINISHES AND HVAC ARE IN POOR CONDITION.
- 12 CURRENTLY THE SPACE LACKS A PLATFORM FOR CHOIR AND BAND PRACTICE

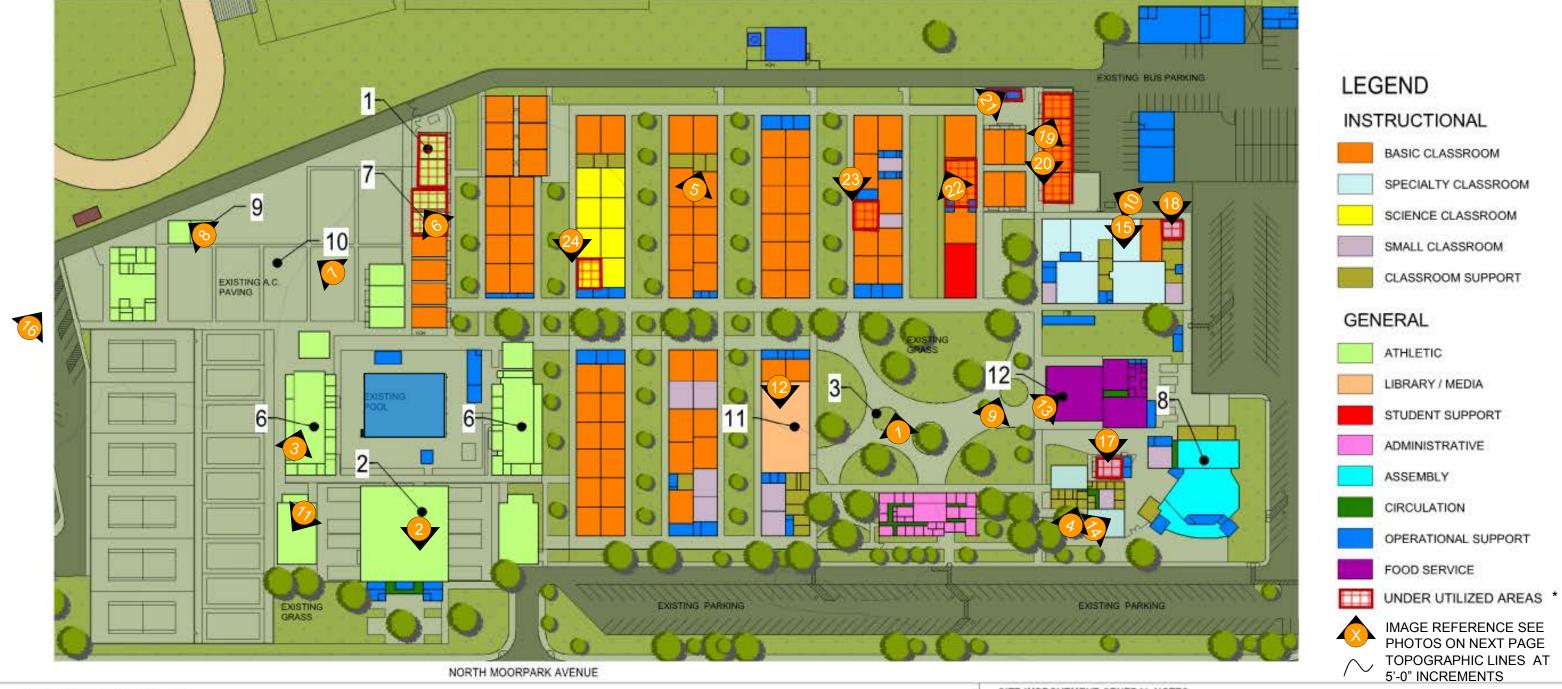
- 1 PORTABLE IN POOR CONDITION. REMOVAL NEEDED
- ACOUSTICAL ISSUES IN GYM, INVESTIGATION NEEDED.

INTENT TO KEEP AESTHETICS OF EXPOSED STRUCTURE | 7 FOOTBALL PLAYER LOCKER ROOMS IN
- 3 CONCRETE SLAB SETTLEMENT ISSUES
- 4 PORTION OF BLEACHERS, REQUIRES UPGRADE
- 5 NO HVAC IN MULTI PURPOSE / CAFETERIA
- 6 LOCKER ROOMS AND LOCKERS IN POOR CONDITION. NEED REPLACEMENT
- 7 FOOTBALL PLAYER LOCKER ROOMS IN PORTABLE BUILDINGS WITH POOR VENTILATION, 10 NEED PERMANENT STRUCTURE.
- B GROUND WATER INTRUSION ISSUE BELOW THE STAGE OF PERFORMING ARTS BUILDING
- WEIGHT ROOM FOR ALL SPORTS EXCEPT FOOTBALL IN SHIPPING CONTAINER WITH POOR VENTILATION. NEED FOR PERMANENT STRUCTURE.
- 10 EXISTING A.C. PAVING OF BASKETBALL COURTS WITH FADED STRIPING AND EXCESSIVE CRACKS ON GROUND SURFACE.
- 11 LIBRARY IN NEED OF FULL MODERNIZATION, CARPET IS IN POOR CONDITION, HVAC NEEDS REPAIR.
- 12 CURRENTLY THE SPACE LACKS A PLATFORM FOR CHOIR PRACTICE

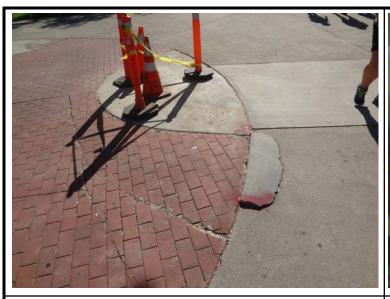
Photo -1
Concrete and Site Work Issues
Throughout the site there are cracked concrete

pavers and concrete surfaces.

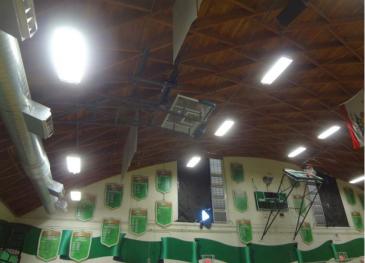
Photo -2

Gym
The gym currently has no HVAC. The acoustic tiles were removed and it now has a

reverberation issue. The sport flooring also

shows signs of aging.

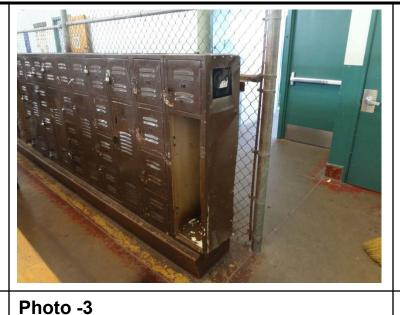
Locker Rooms
The locker rooms are in poor condition. Several lockers have been damaged.

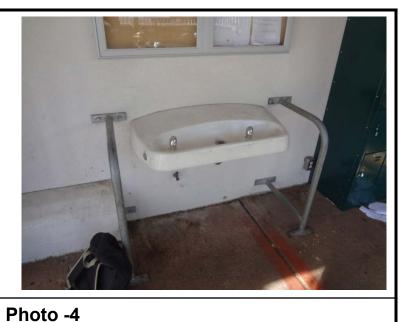
Accessibility Upgrades
Throughout the site there are accessibility compliance issues.

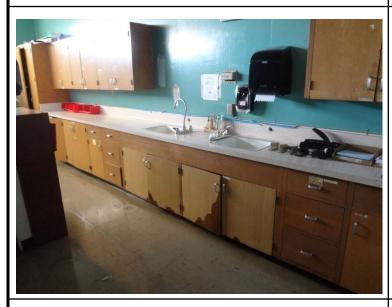
Photo -5 Classrooms The finishes in

The finishes in the classrooms show significant wear and tear. The sink does not meet accessibility requirement.

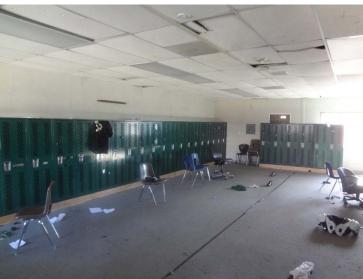
Photo -6
Football Locker Rooms

The football player locker rooms are in portable buildings. Finishes are in poor conditions and ventilation may be insufficient.

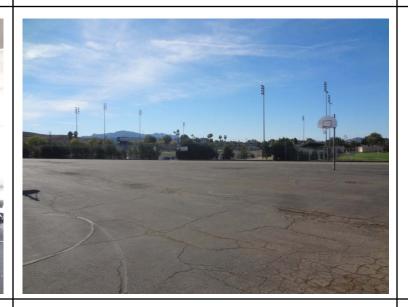
Photo -7
Black Top
The backetball court surfaces h

The basketball court surfaces has extensive cracks and the striping are heavily faded.

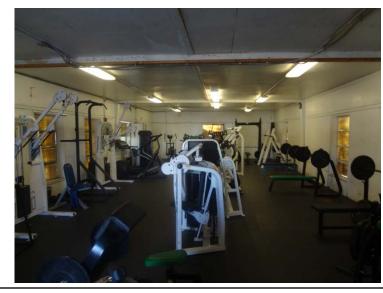
Photo -8 Sports Weight Room

Currently the weight room for all other sports besides football is located in a large temporary structure that has insufficient ventilation, lighting and thermal insulation.

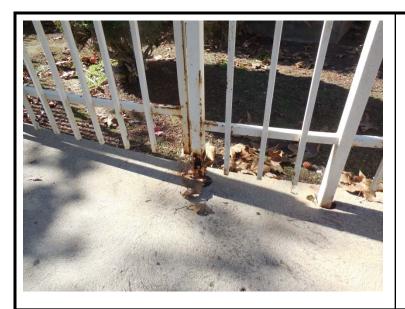
Photo -9 Fencing

The fencing throughout campus shows extensive rust and water damages.

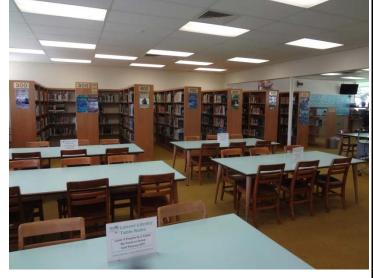
Photo -11 Activity Rooms

The activity rooms have not been upgraded. The HVAC does not function properly. The windows lack shading and have been painted to reduce glare and heat.

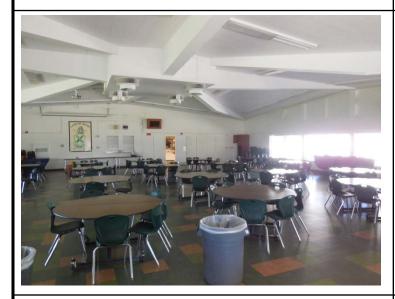
Photo -13 Cafeteria / MPR

The cafeteria doubles as the campus MPR. There is no air conditioning and the finishes are dated. The windows lack shading and have been painted to reduce glare and heat.

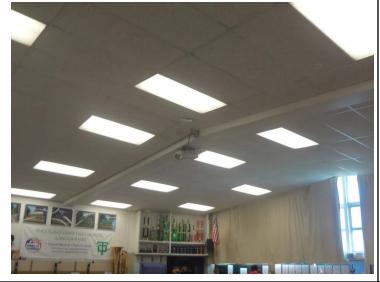
Photo -14
Band Room & Chorus Room

The room is in original condition and lacks a platform, which may be difficult to fit the existing space.

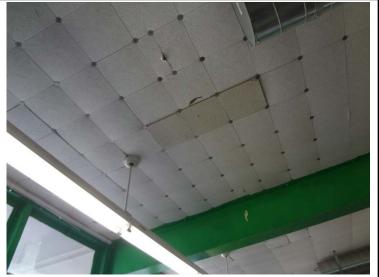
Photo -15 Classroom Ceilings

The condition of the ceiling tiles is poor and mechanical fasteners have been added to hold the tiles in place in expense of the appearance

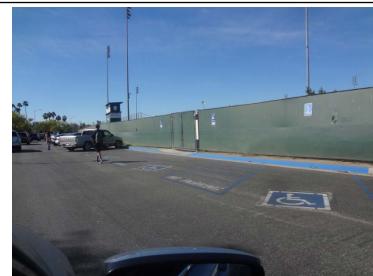
Photo -16

Accessible Parking

There is no accessible pathway to the accessible parking stalls in front of the football stadium.
