CVUSD Facilities Master Plan

Redwood Middle School I Site Analysis

233 W Gainsborough Road I Thousand Oaks, CA 91360 Conejo Valley Unified School District January 10th, 2017

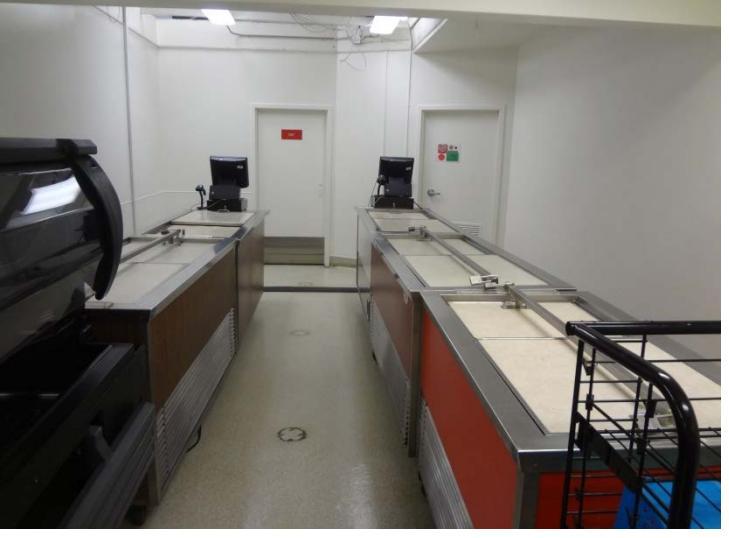
Photo -2

Food Service

The food service lunch line is congested and was expanded into the MPR making the MPR too small to function in any capacity.

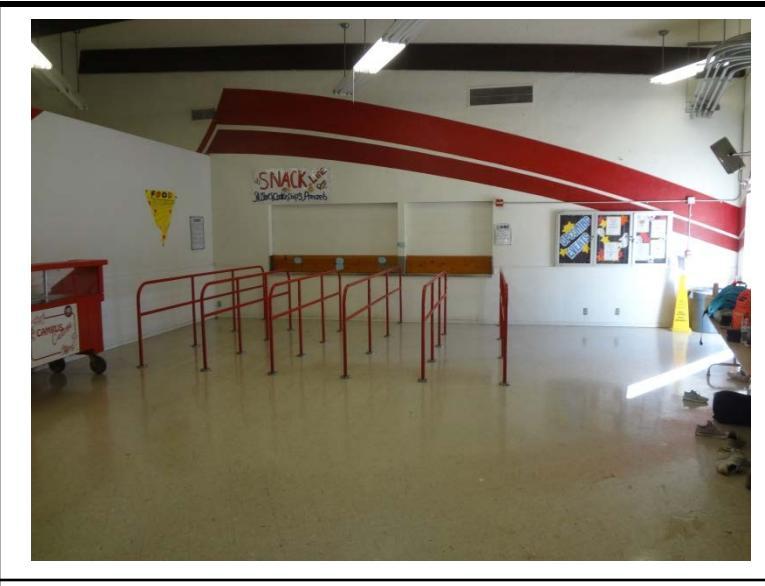
Photo -3

Food Service

The food service lunch line is congested and was expanded into the MPR making the MPR too small to function in any capacity.

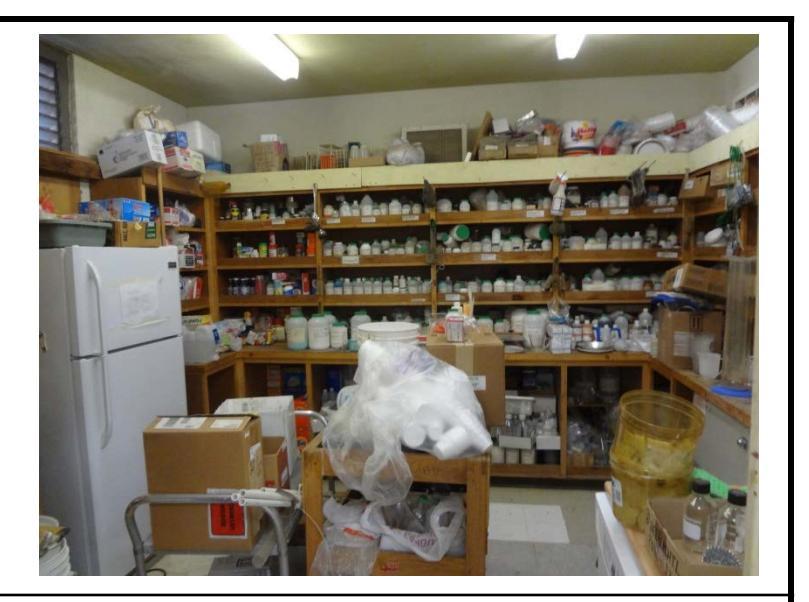
Photo -4

Chemical Storage

The chemical storage for the chemistry classrooms appears undersized.

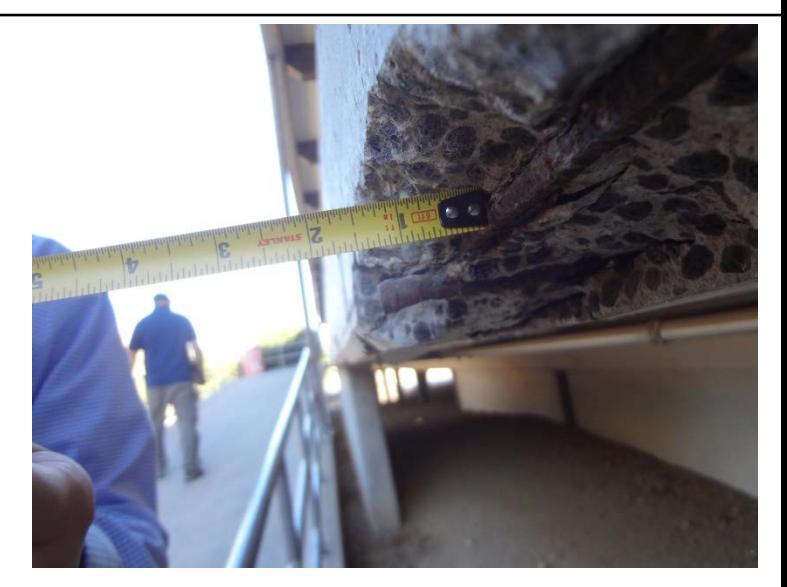
Photo -8 Elevated Classroom Walkway Spalling Concrete spalling occurs throughout the perimeter of balconies.

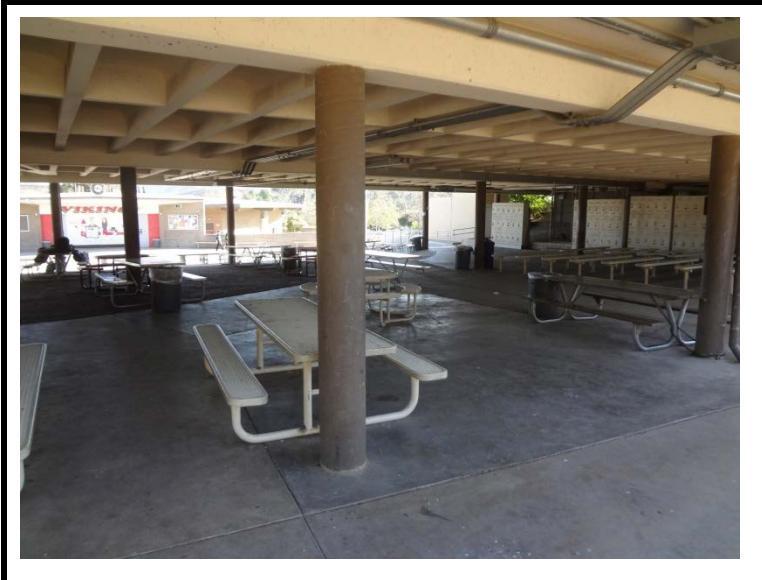
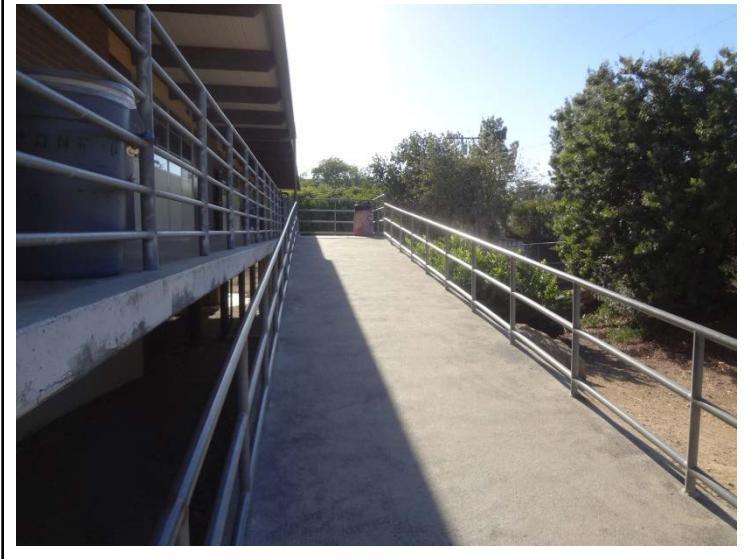
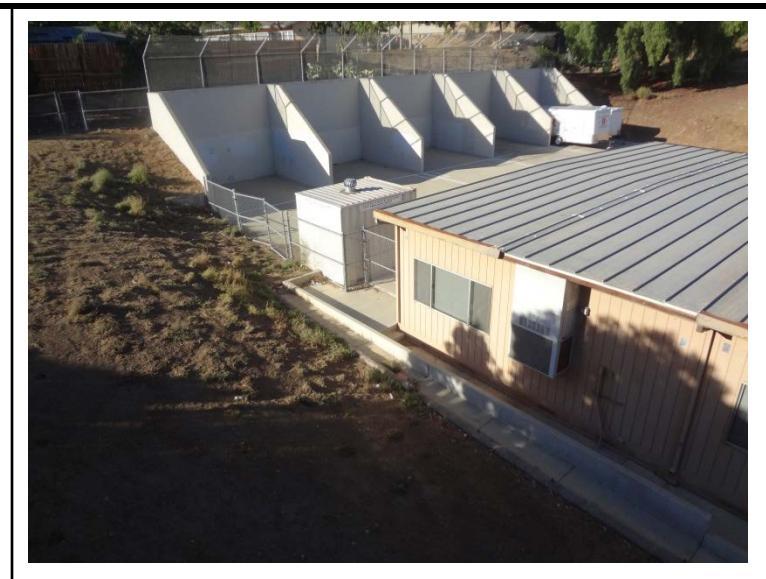
Photo -9 Covered Lunch Area Current covered lunch area beneath classroom buildings are not large enough to fit entire student population	Photo -10 Elevated Classroom Ramp The ramp of the elevated classroom building is not compliant for wheelchair access. It is also a part of the egress path.	Photo -11 Safe Dispersal Path There is currently no paved pathway for emergency egress to the eastern portion of the field.	F A c
Photo -13	Photo -14	Photo -15	F

Photo -13 Fencing Beneath Classroom Building There is a need for fencing under the classroom buildings to increase security. Photo -14 Concrete Deterioration There is concrete work that is needed throughout campus. Photo -15 Elevator The elevator has not been certified through DSA.

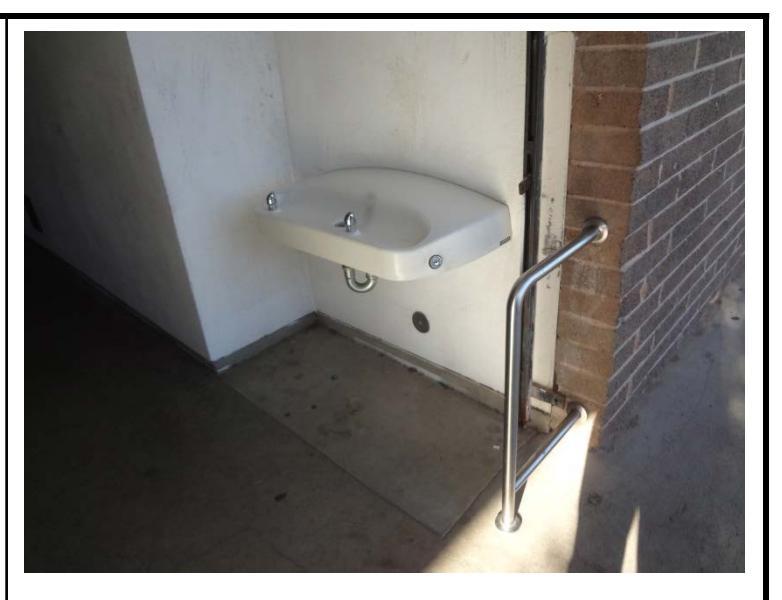
Photo -12 Accessibility Upgrades

Accessibility upgrades are needed throughout campus.

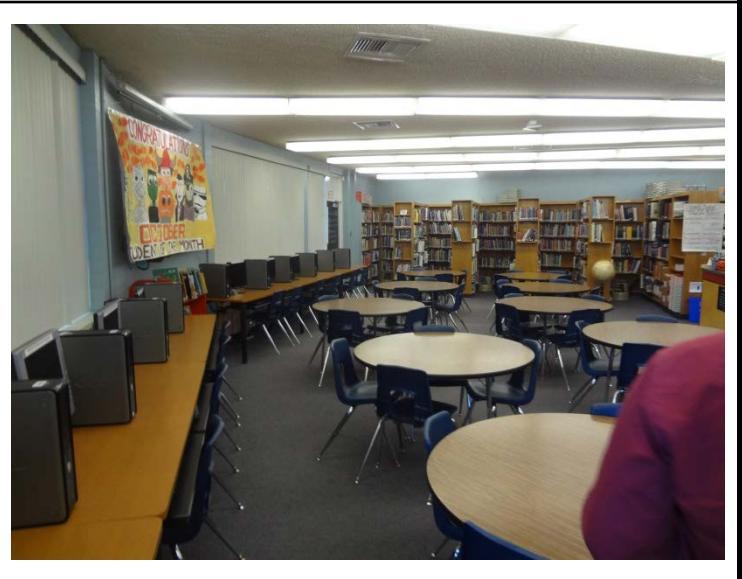
Photo -16

Library

The library is undersized to handle the student population.
