Horizon Hills School | Survey

33 Greta Street I Thousand Oaks, ca 91360

Conejo Valley Unified School District

November 1, 2016 Draft v1

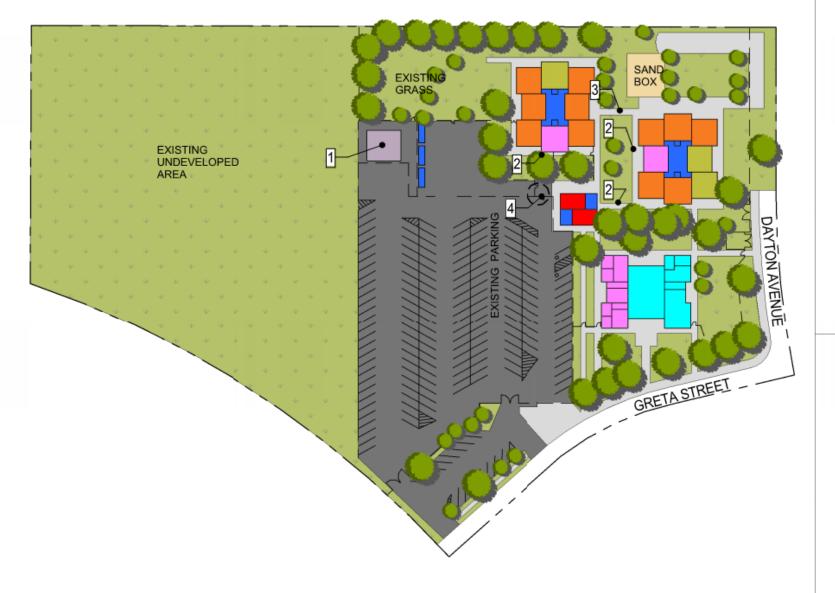
- 1 PLUMBING AND WATER HOOK UP NEEDED
- DRAINAGE ISSUES, UNDERGROUND DRAINAGE NOT WORKING, LOCATION NEED TO BE REWORKED
- 3 NEEDS HANDRAIL TO CREATE ACCESSIBLE PATH OF TRAVEL TO UPPER BUILDINGS
- MAJOR ACCESS POINT TO SCHOOL NOT ACCESSIBLE. NEED TO CHANGE GATE

- OLDER CLASSROOMS WILL NEEDACCESSIBILITY UPGRADES ON HARDWARE THRESHOLDS AND SINKS
- EXTERIOR DRINKING FOUNTAINS WILL NEED TO BE MADE ACCESSIBLE
- ACCESSIBILITY UPGRADES NEEDED IN PARKING, GATE LOCATIONS, DOORS, AND SOME PATHWAYS
- SOME ACCESSIBILITY UPGADES NEEDED IN RESTROOMS TO BECOME FULLY COMPLIANT

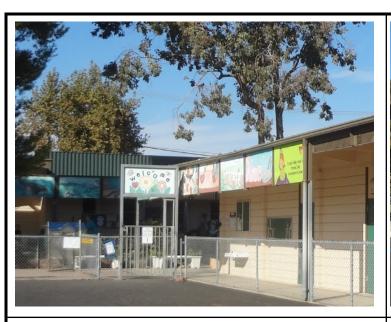
Photo -1 **Building 5**

Primary entry location next to restrooms. Difficult to see from street.

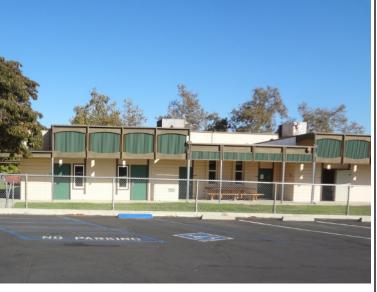
Photo -2 **Building 1**

Multi Purpose building at the front of campus. Secondary entry point to campus through the multi purpose building.

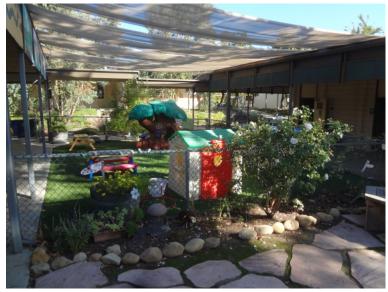
Photo -3 **Building 3**

Shaded courtyard with artificial turf and preschool playground equipment. Nicely landscaped and well protected from the sun.

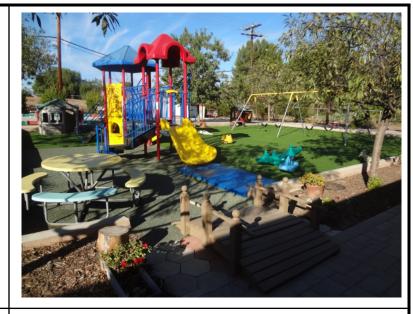
Photo -4 **Building 2**

Backside of building 2 is a playground area with artificial turf and play equipment. The equipment is well maintained.

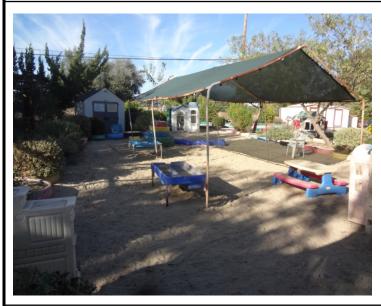
Photo -5 **Building 2**

Sand box next to playground area has shade device and play equipment.

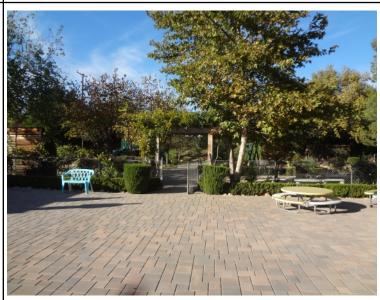
Photo -6 **Building 3**

Gated entry to exterior landscaped area between building 3 and portable, newly updated with pavers and lush landscape.

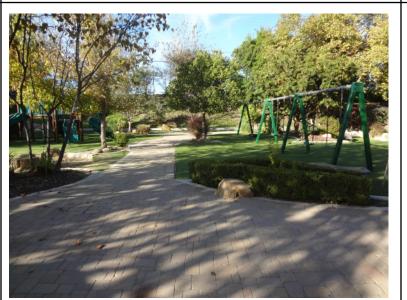
Photo -7 **Building 3**

Exterior landscaped area between building 3 and portable, newly updated with pavers and lush landscape.

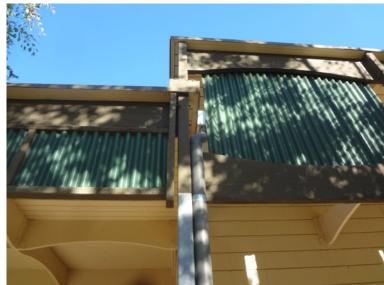
Photo -8 **Building 2**

Gutter system of building has been reworked but is currently spilling water on ground surface and then diverted to storm drains.

Modernization consists of projects targeted at improving the educational environment of classrooms and academic spaces, is developed around improving the overall condition and appearance of classrooms in permanent and portable facilities. The majority of this work is targeted at infrastructure related issues through campus, dealing with an old HVAC system and roofing upgrades. In addition, the roof drainage issues needs to be addressed.

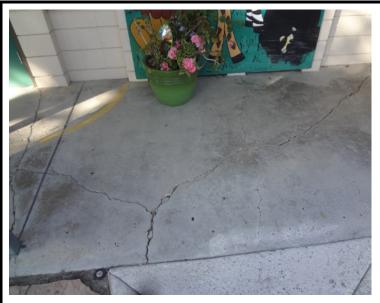
Photo -9
Building 3
Existing concrete pathways around the campus are old and cracking

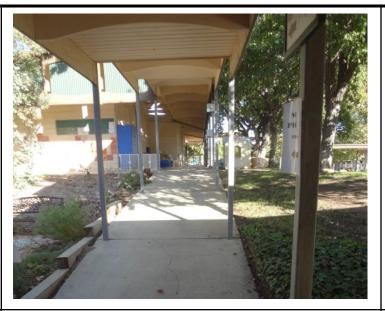
Photo -10

Building 2
Covered concrete walkway between building 2
and 5 is very steep and does not comply with
accessibility standards

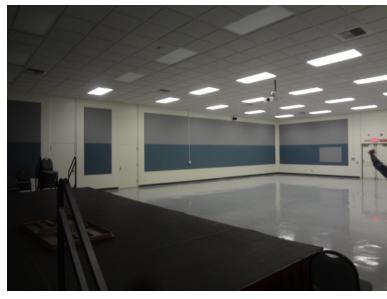
Photo -11

Multi Purpose room with temporary stage. The temporary stage is borrowed from a different campus, school is in need of their own permanent stage

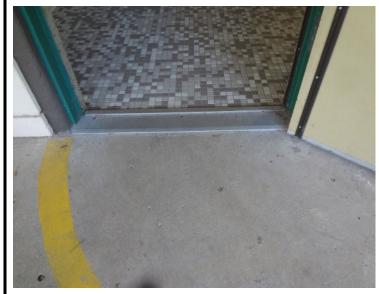
Photo -13
Building 5
Typical thresholds have been updated throughout the campus

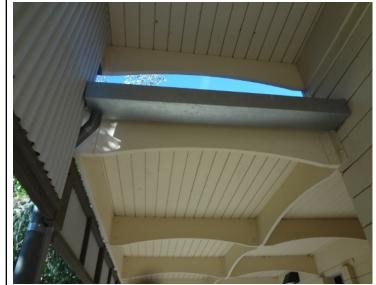
Building 2
New roof drainage to combat issues with ground drainage not working

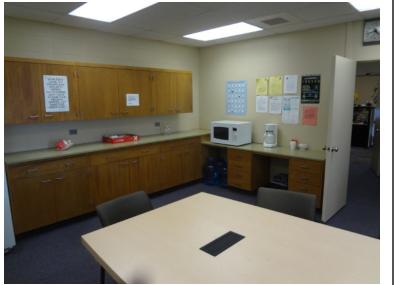
Building 1
Interior Staff room in the multi purpose building that has older finishes and no accessibility upgrades

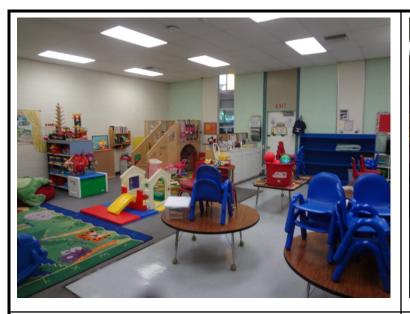
Photo -17 Building 2

Typical classroom with unique play equipment has updated floor finishes and good play equipment. Casework and sinks have not been upgraded

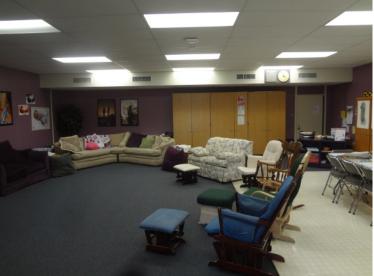
Photo -18 Building 2

Typical classroom with unique layout for prebirth parenting classes, has updated floor finishes and good play equipment. Casework and sinks have not been upgraded

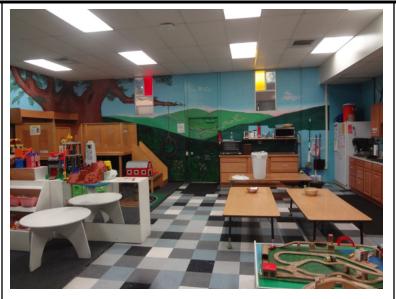
Photo -19 Building 2

Typical classroom with unique play equipment has updated floor finishes and good play equipment. Casework and sinks have not been upgraded

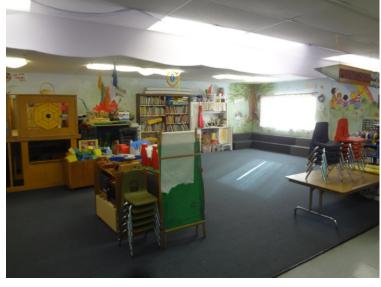
Photo -20 Building 4

Portable classroom building is relatively new, but has no plumbing connection

One of the biggest concerns of the faculty at the school is the need for plumbing in the modular classroom building which they currently will carry large buckets or water to supply the classroom with water for the children for their arts and crafts.

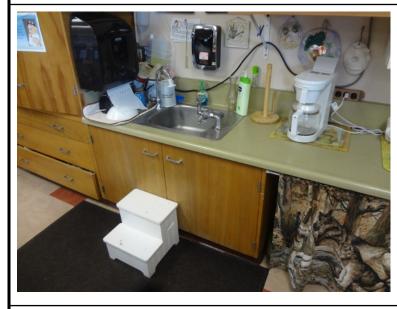
Photo -21 Building 3

Typical sink in classrooms, not current with accessibility standards

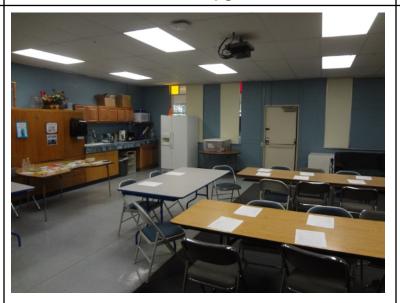
Photo -22 Building 2

Staff room has newer floor finishes, Casework and sinks have not been upgraded

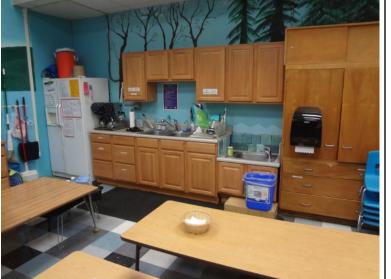
Photo -23

Typical classroom with unique play equipment has updated floor finishes and good play equipment. Casework and sinks have not been upgraded, has additional sink/kitchen area

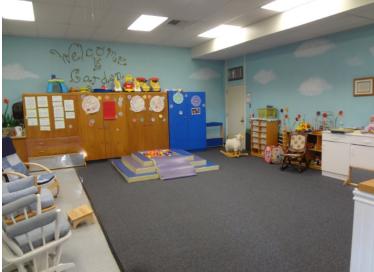
Photo -24 Building 2

Typical classroom with unique play equipment has updated floor finishes and good play equipment. Casework and sinks have not been upgraded

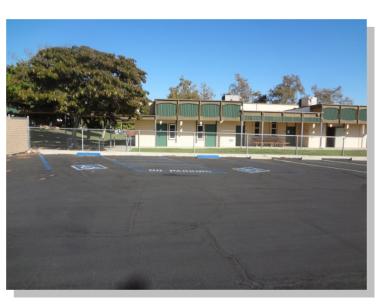
Photo -1 The current parking lot has accessible stalls, however they do not have detectable warnings and the pathway requires the pedestrians to use the parking lot to access the site.

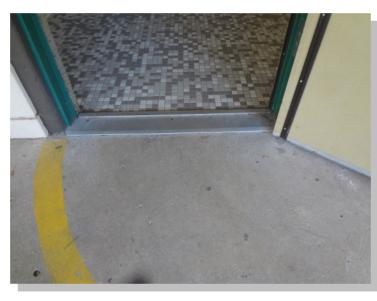
Photo -2 Door thresholds throughout campus have been upgraded to accessibility compliant thresholds

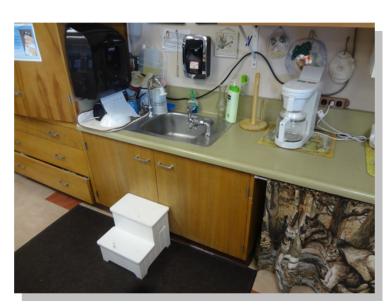
Photo -3 The building sinks have not been upgraded to comply with accessibility standards
