CVUSD Facilities Master Plan

Redwood Middle School I Site Analysis

233 W Gainsborough Road I Thousand Oaks, CA 91360 Conejo Valley Unified School District January 10th, 2017

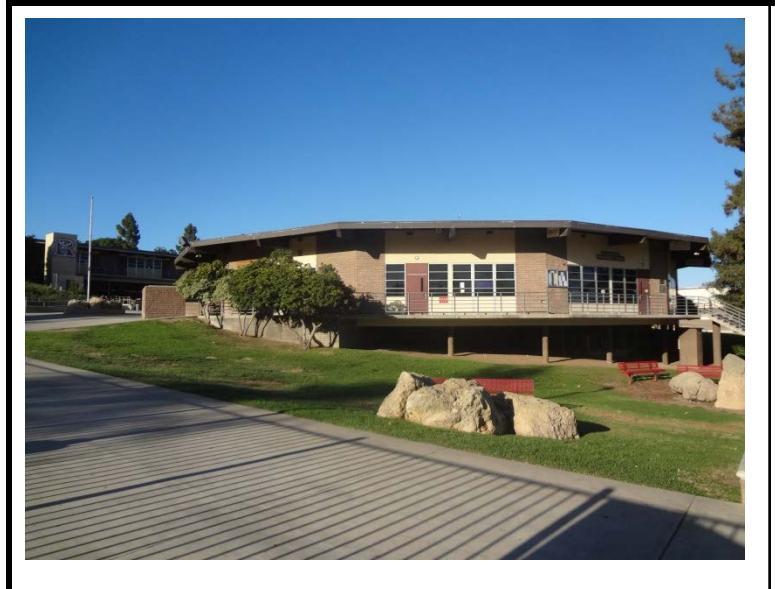
Photo -1 Curb Appeal – View of Administration The polygonal shaped building elevated above a sloping site.

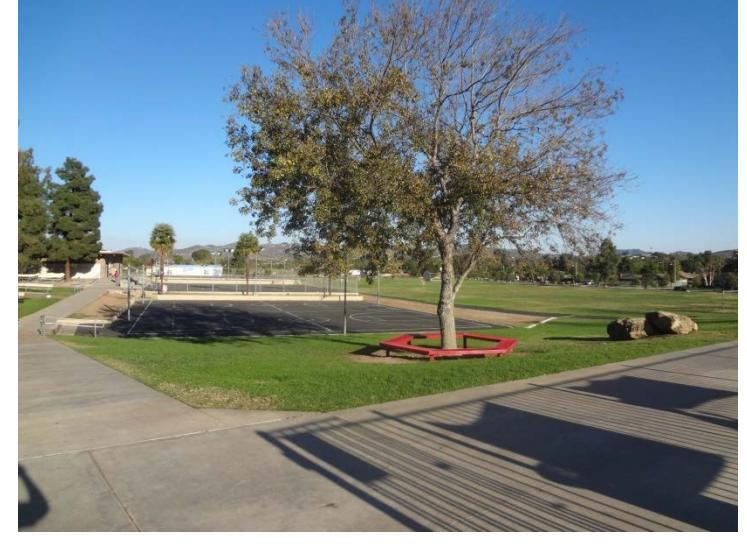
Photo -2

Curb Appeal – View of Play Area

Large gentle sloping site with adequate hard top and play area as well as views of mountains that surround the campus in the distance.

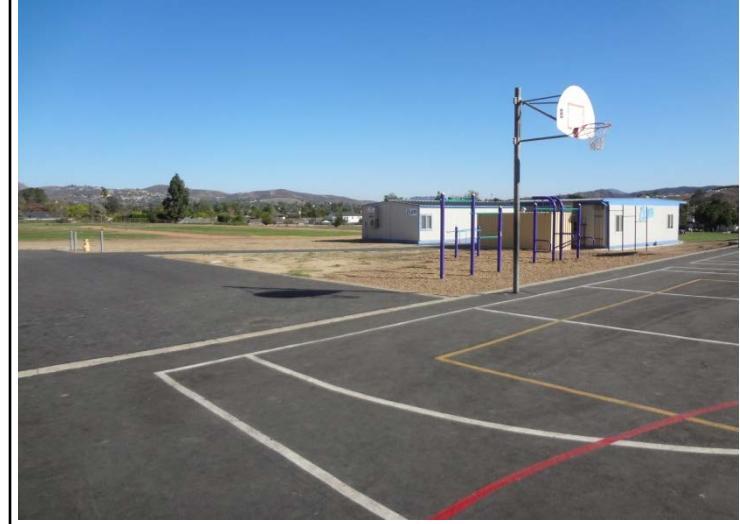
Photo -3

Curb Appeal – View of Play Area Large blacktop area with view of the mountains in the distance.

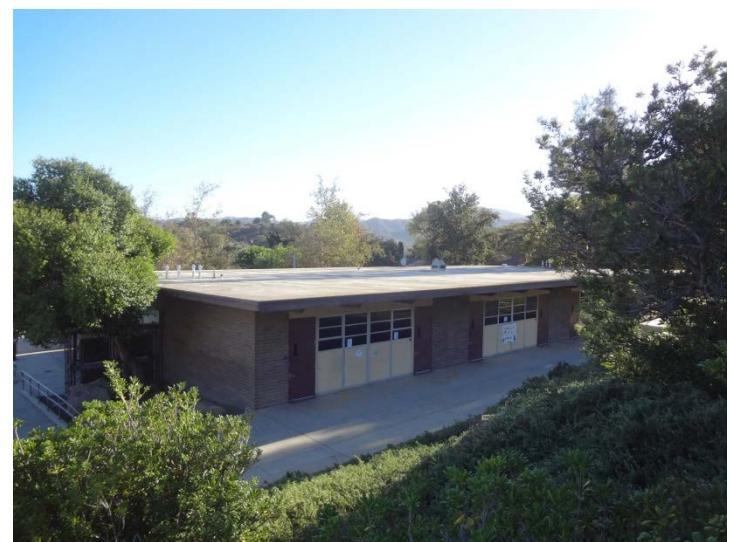
Photo -5 **Curb Appeal – View of Classrooms** Classroom buildings with split face CMU façade and are nestled into the hillside with mature foliage.

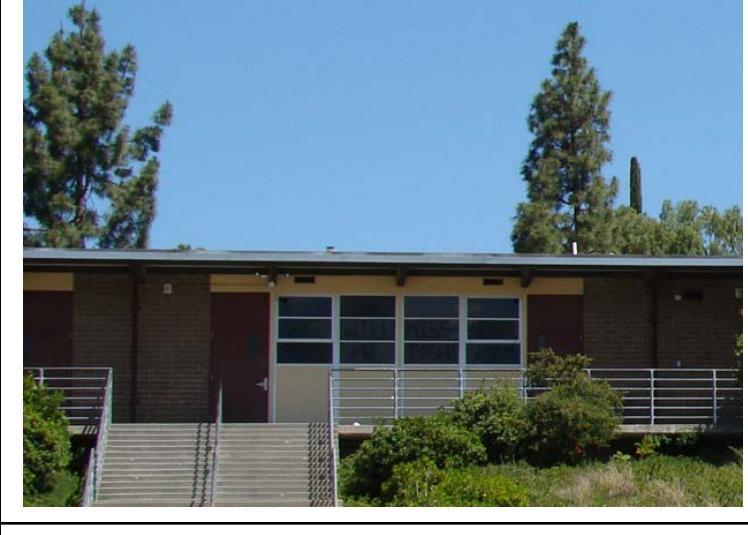
Photo -6

Curb Appeal – Elevated Classrooms Elevated classroom buildings command a view over the campus and the surrounding mountains.

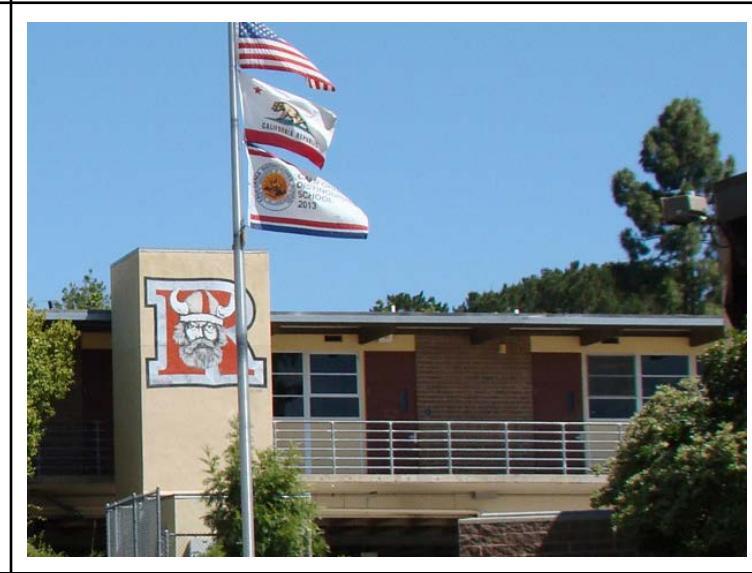
Photo -7

Curb Appeal – Elevated Classrooms

The elevator with the school logo helps create symmetry for the elevated classroom buildings.

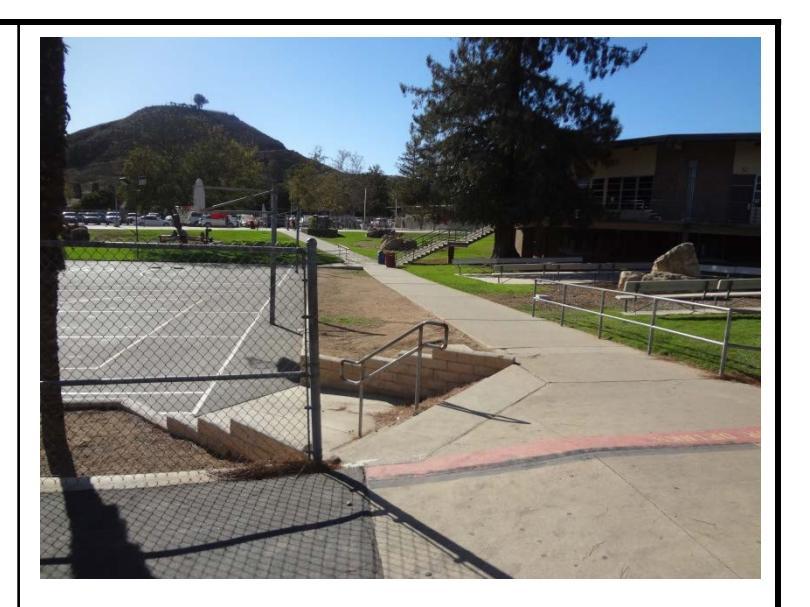
Photo -4

Curb Appeal – View of Playfield

Large gentle sloping site with adequate hard top and play area as well as views of mountains that surround the campus in the distance.

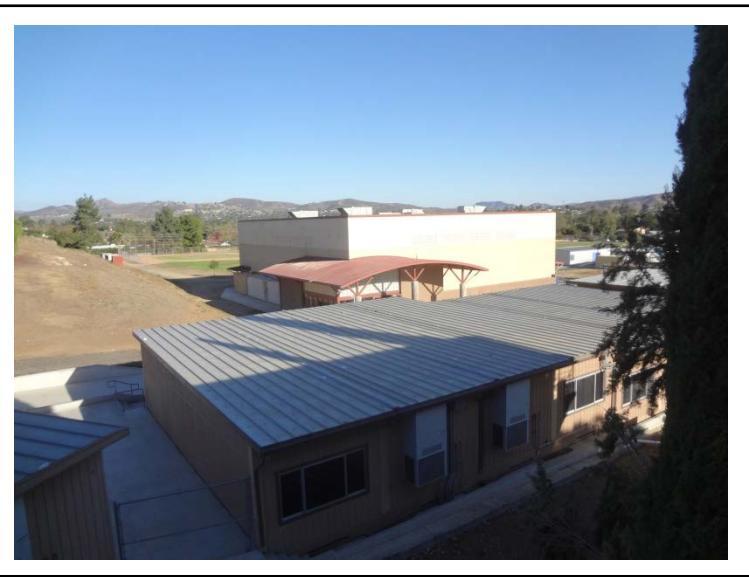
Photo -8 **Curb Appeal – Elevated Classrooms** Elevated classroom buildings command a view over the MPR and the surrounding mountains.

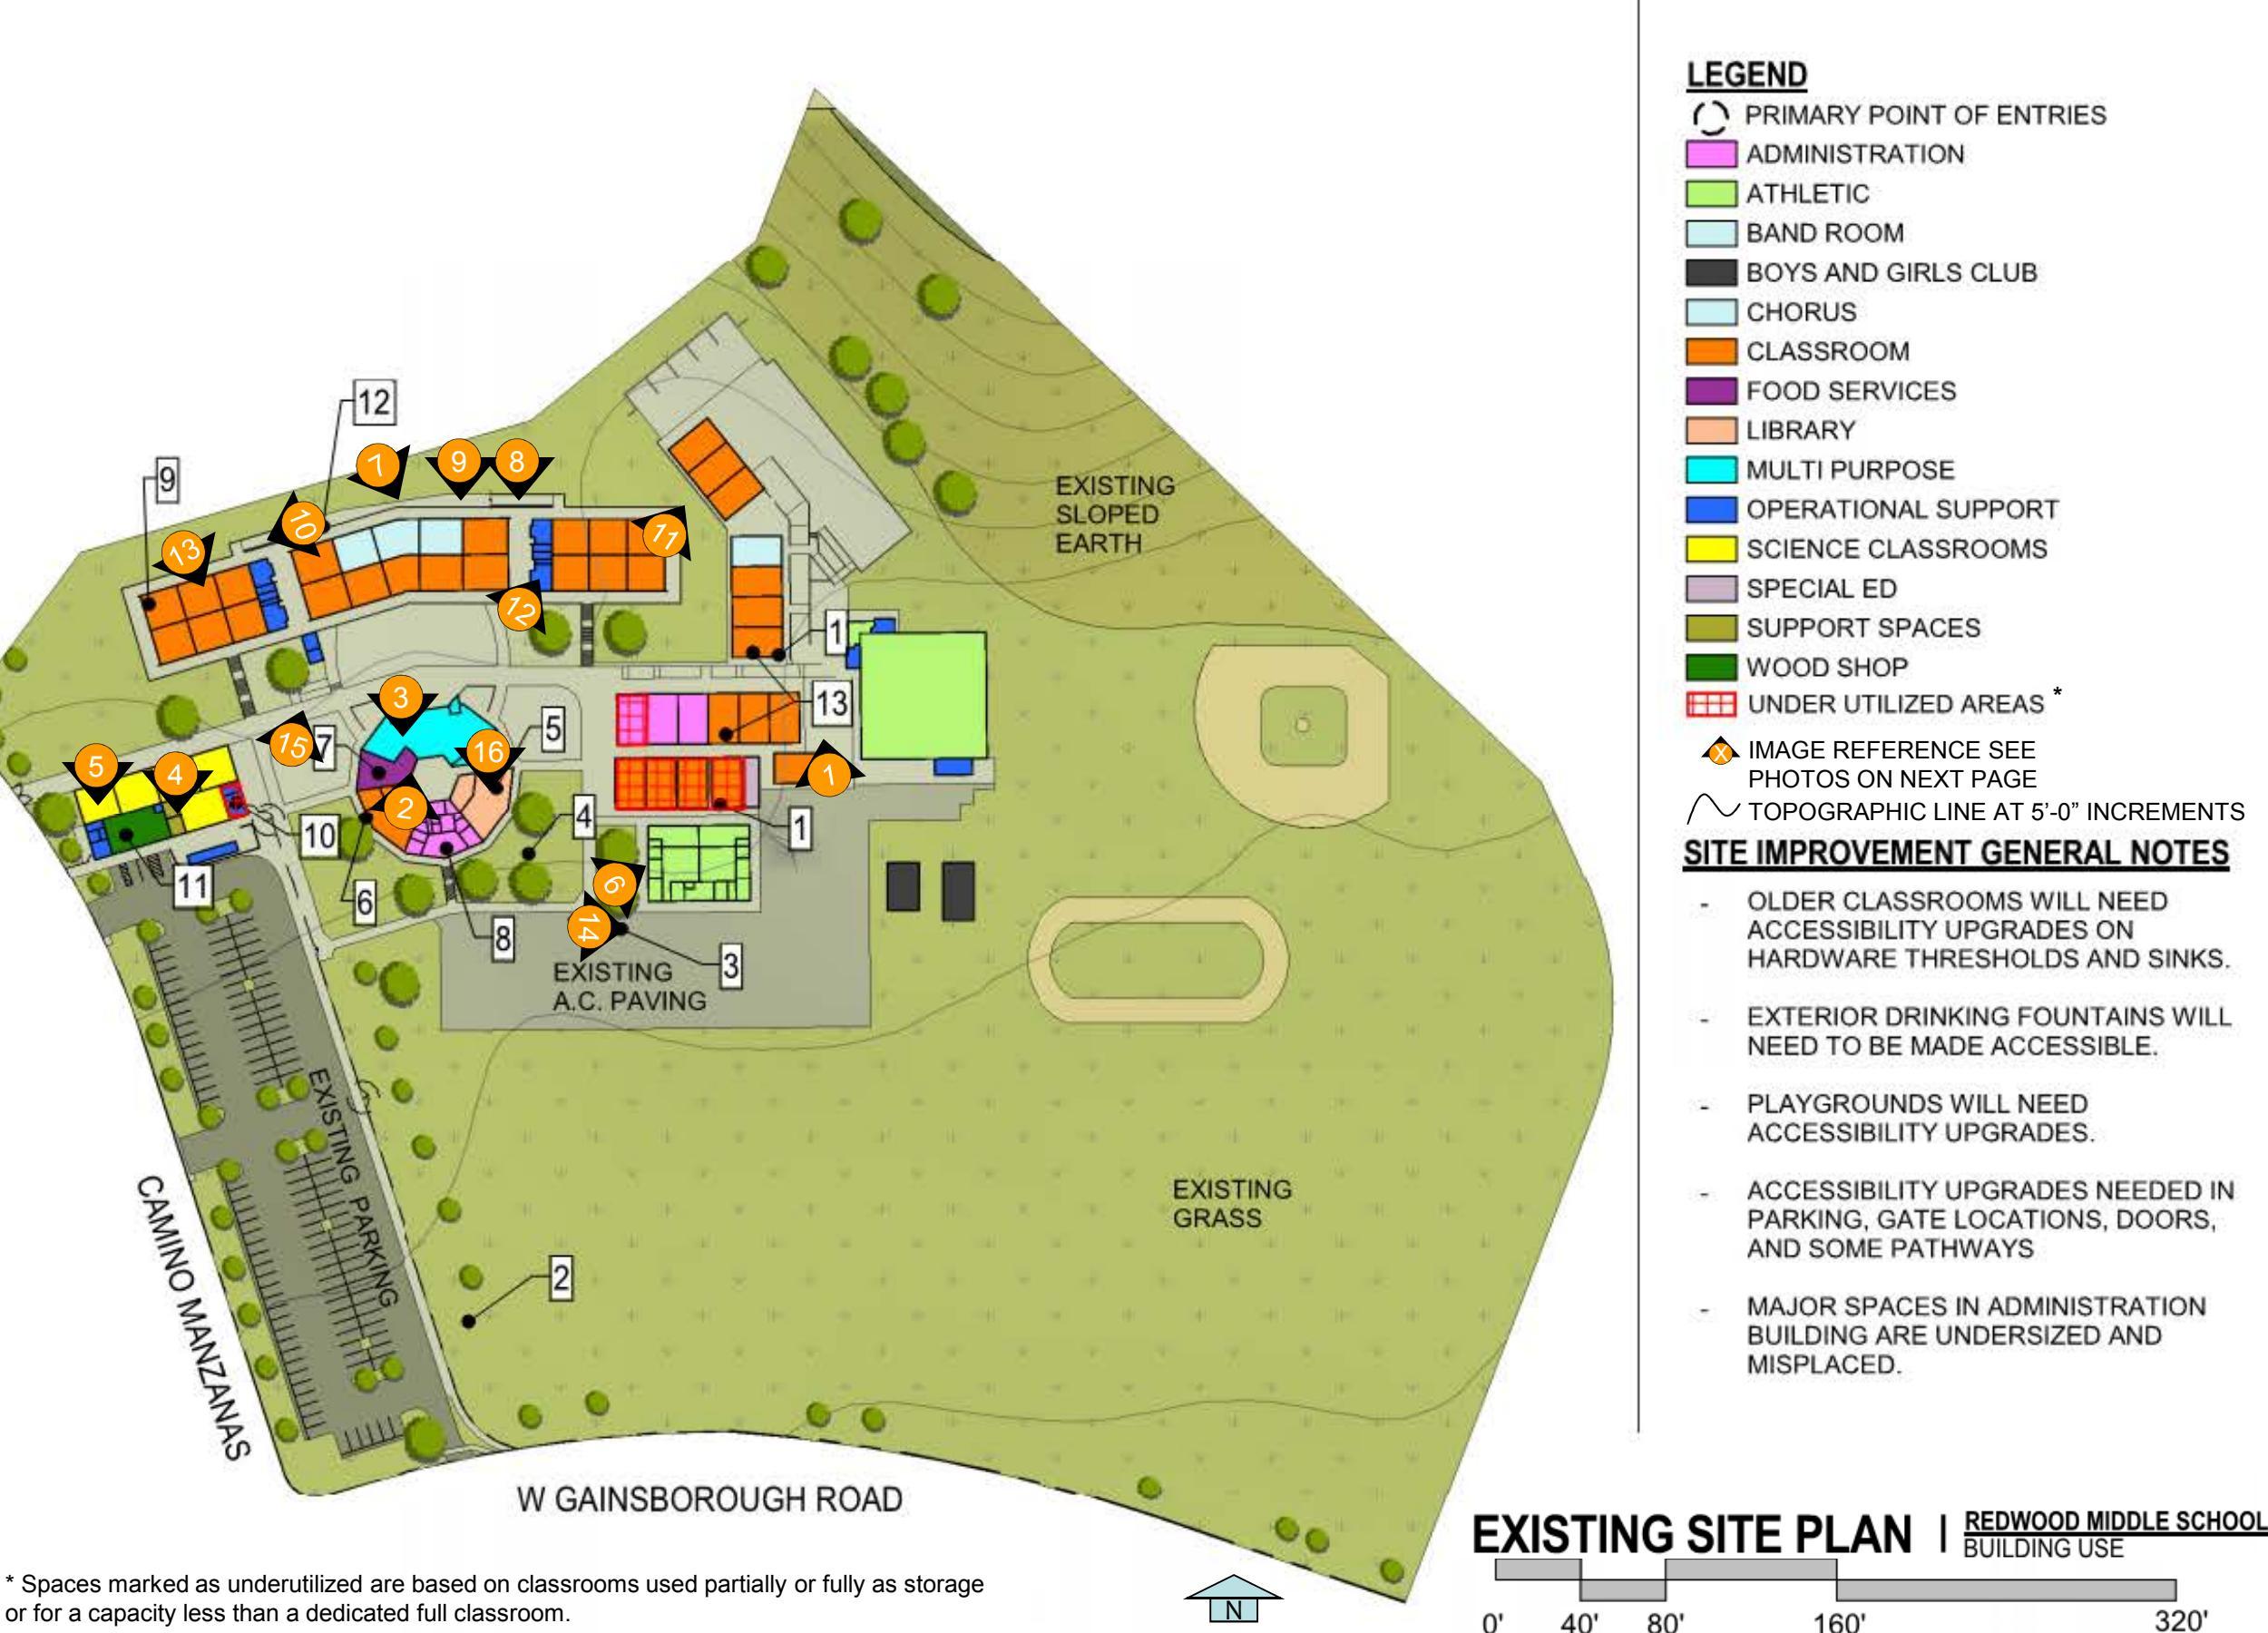
- 1 FLOODING AND ODOR ISSUES
- 2 FUTURE BOYS AND GIRLS CLUB LOCATION.
- 3 CONCRETE CRACKING AND SETTLEMENT ISSUES.
- 4 DESIRED SHADE STRUCTURE LOCATION.
- LIBRARY TOO SMALL FOR NEEDS OF CAMPUS.
- 6 INSUFFICIENT WINDOW OPENING FOR LINE OF SIGHT TO THE SCHOOL ENTRANCE.
- 7 KITCHEN AND SERVING AREA ARE INEFFICIENT AND UNDERSIZED.
- 8 ADMINISTRATION OFFICE LACKS DIRECT LINE OF SIGHT TO ENTRANCE AND IS UNDERSIZED
- DESIRE FOR FENCING UNDERNEATH 9 BUILDING TO IMPROVE SECURITY
- 10 POSSIBLE LOCATION FOR RELOCATED STUDENT STORE.
- 11 WOOD SHOP MAY NEED MODERNIZATION, DUST COLLECTOR ETC. IMMEDIATE LINE OF SIGHT TO PARKING LOT MAKES IT A POSSIBLE ALTERNATIVE LOCATION FOR ADMINISTRATION OFFICE.
- 12 CONCRETE SPALLING ISSUES WITH WALKWAYS AROUND BUILDING.
- 13 TOO MANY AGING PORTABLES, POTENTIAL LOCATION FOR NEW BUILDING TO RELIEVE THE CONJESTED ADMINISTRATION BUILDING.

43% of the student population is involved in some form of performing arts class. A new dedicated performing arts classroom building is critical to the success of the campus. This will make other needs to the campus possible by reorganizing the current classes allowing for the expansion the library, MPR and moving the administration to a different portion of the building or campus with a view of the campus entrance.

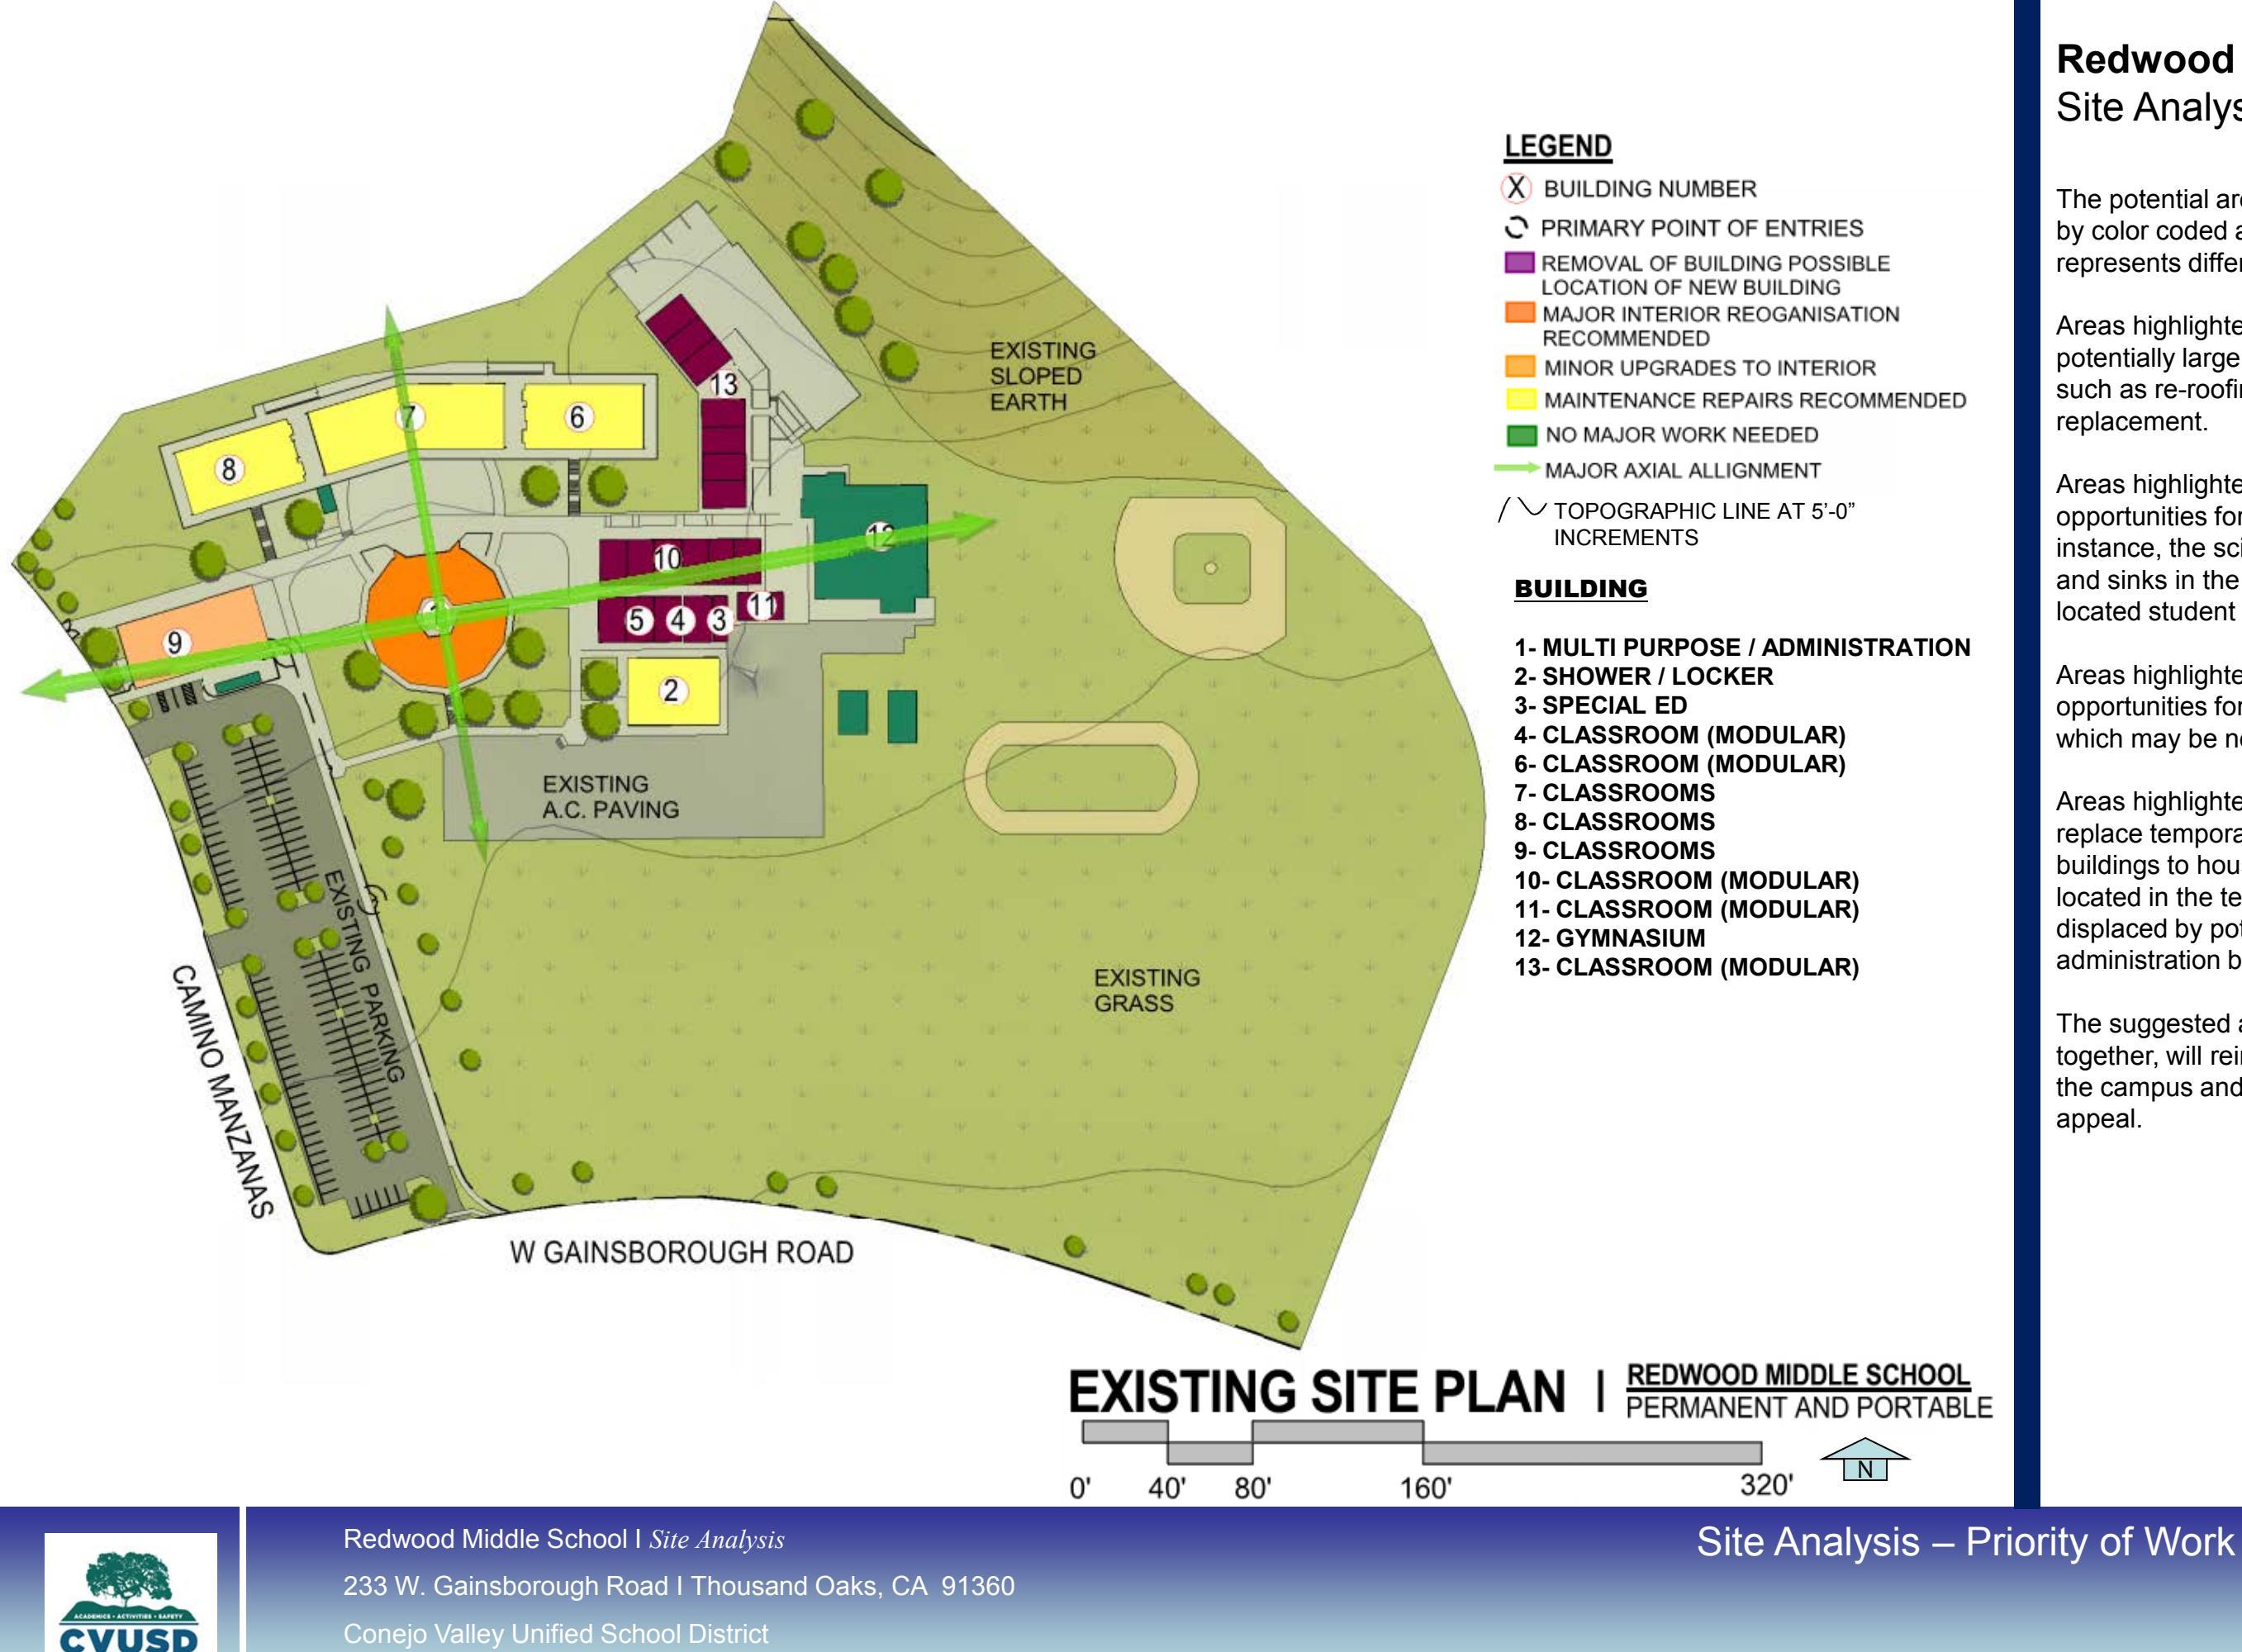
The potential area of improvement can be illustrated by color coded area on campus. Each color represents different scale of improvement.

Areas highlighted in yellow represent opportunities for potentially larger scale maintenance and repair work such as re-roofing, and concrete slab repair or replacement.

Areas highlighted in red represent opportunities to replace temporary classroom buildings with new buildings to house functions and classes previously located in the temporary buildings and those displaced by potential interior work in the administration building.

The suggested area of improvement, if completed together, will reinforce the organizational scheme of the campus and unify the appearance and curb appeal.
