Thousand Oaks High School I Site Analysis

2323 N Moorpark Rd, Thousand Oaks, CA 91360

Conejo Valley Unified School District

January 10th, 2017

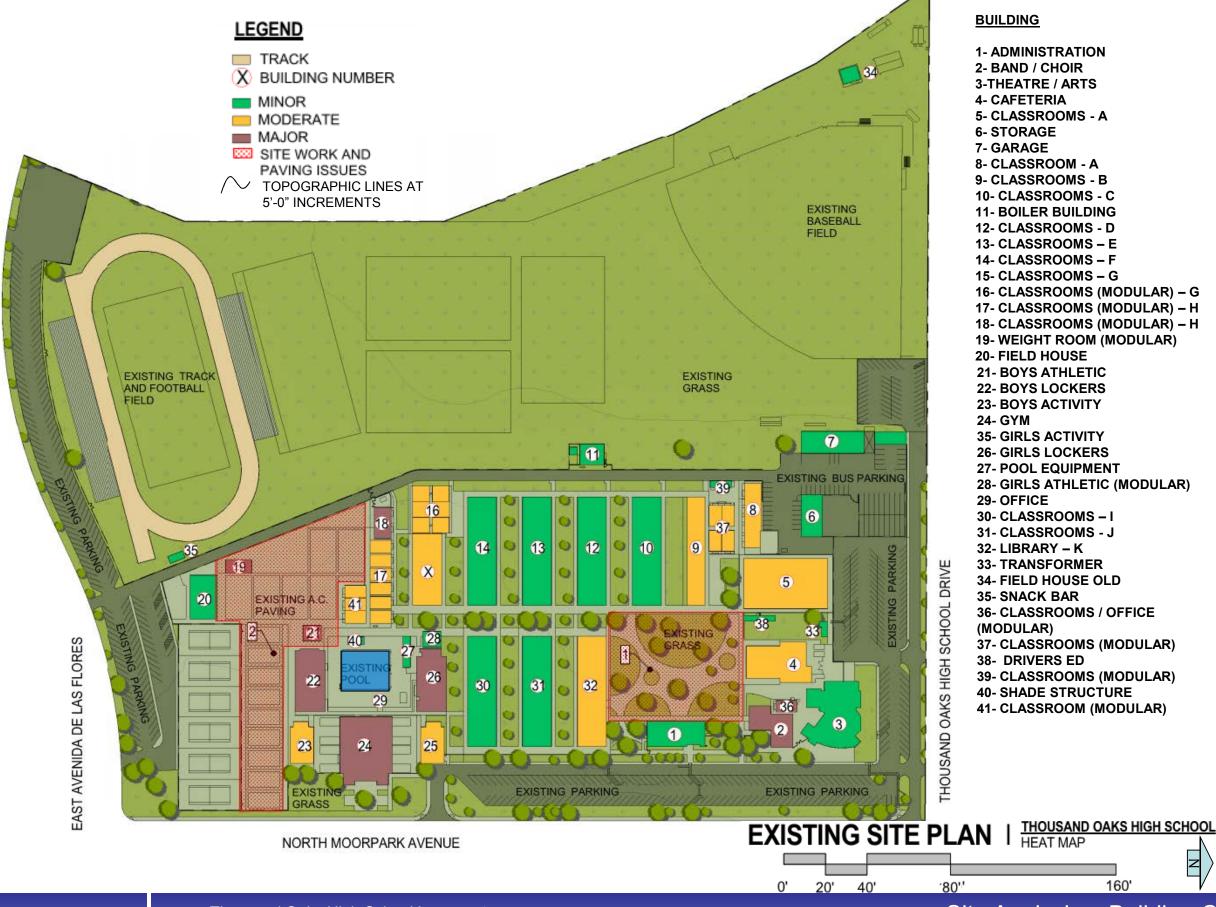
Thousand Oaks High School Site Analysis: Building Condition Map

This building condition map represents the level of improvement needed throughout the campus.

Green buildings represent opportunities for minor improvement such as replacement or touch-up of interior finishes and ADA upgrades. Some of the buildings may have isolated locations with needs for repair and equipment replacement. It should be noted that isolated locations for infrastructure repair and replacement is often the case regardless what condition category a building is labeled.

Red buildings represent opportunities for major improvement that may be a complete building replacement or significant renovation that involves modification of the building footprint and appearance.

In addition to illustrating the conditions of the buildings, this diagram also shows the areas of concerns on the site which may need site work and paving repairs.

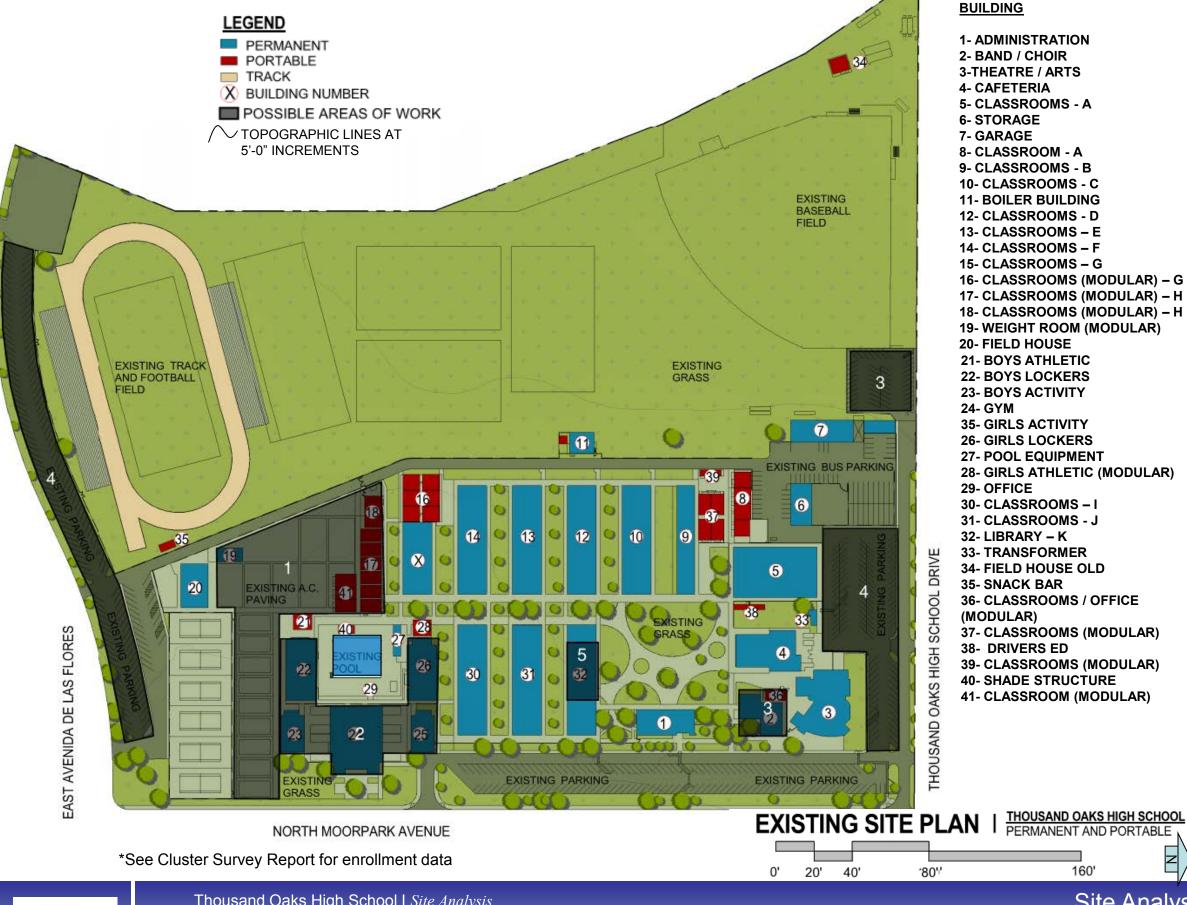
Thousand Oaks High School Site Analysis – Summary

Thousand Oaks High School has many challenges related to aging building conditions and insufficient spaces for the intended functions.

The summarized diagram illustrates area of major opportunities considering the building conditions, priority, and environmental factors

Area 1 represents potential locations and opportunities to replace aging and non DSA certified portable structures with permanent buildings.

Area 2 represents the opportunities for large scale improvement in the athletic complex. The potential works may include significant interior modernization, improvement of building envelope or complete building replacement.
